May 27, 2019

Re: Limited Drainage and Erosion Inspection
Private Asphalt Greenways
Clayton, NC

At your request, a limited erosion inspection of the above property was performed on May 22, 2019. The inspection was performed and report written by Christopher A. Flythe, PE.

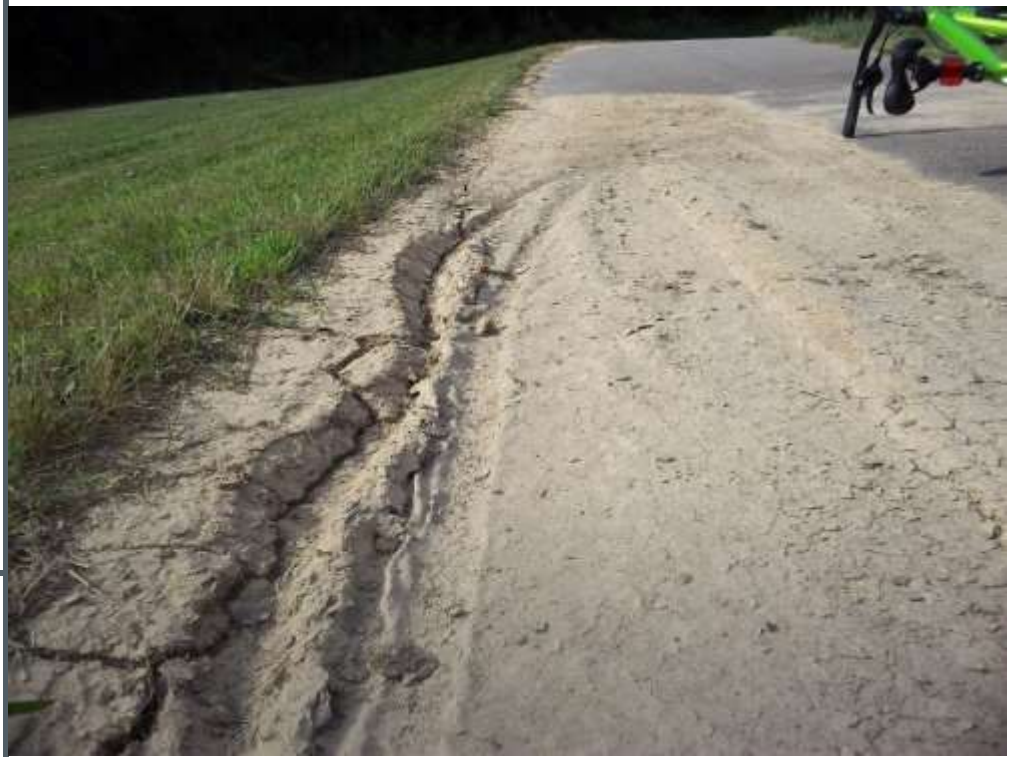
Photo No.
1

In this area, we noted a condition described above as a high shoulder. It is possible that the asphalt may not be properly sloped toward the stream in sections of the greenway. The high shoulder is preventing water from naturally flowing across the pavement. The temporary ponding is allowing sedimentation to occur on the greenway. A contributing factor is the bare soils and lack of vegetation on the slopes uphill from the greenway which is causing minor erosion.

Area #1: High shoulder
and sedimentation

We recommend the shoulder be fine graded to allow water to naturally sheet flow across the greenway, and ensure the asphalt is properly sloped in this direction. We recommend a 2% cross slope in all sections of the greenway (or as specified in the construction details). In addition, all bare soils should be properly vegetated.

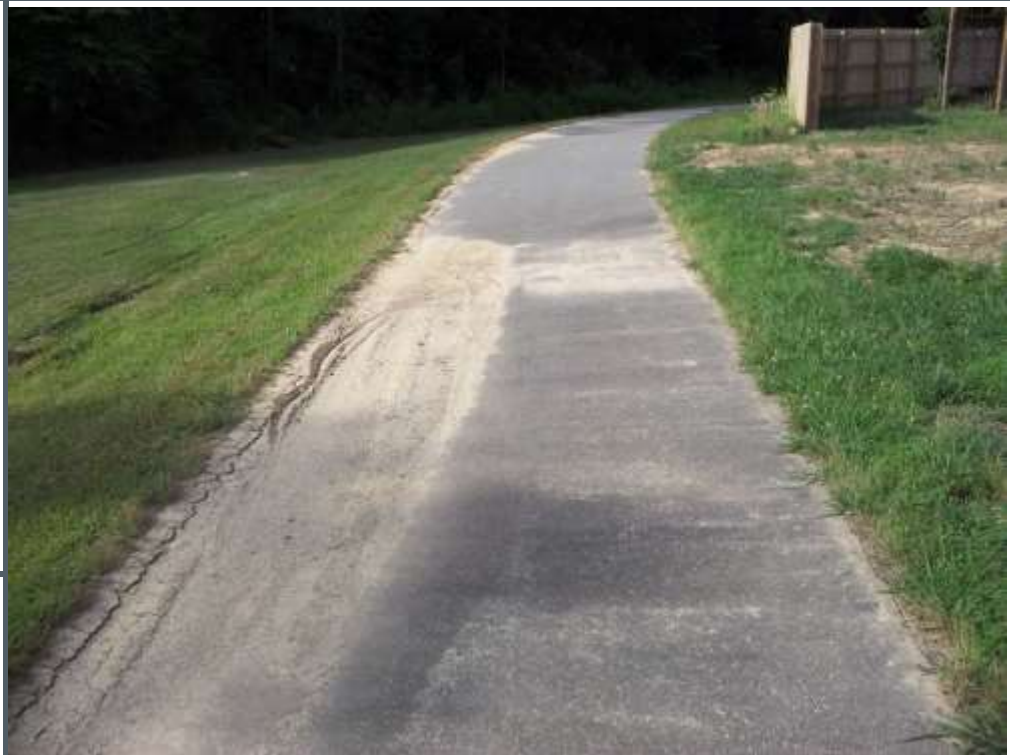
Photo No.
2

Area #1

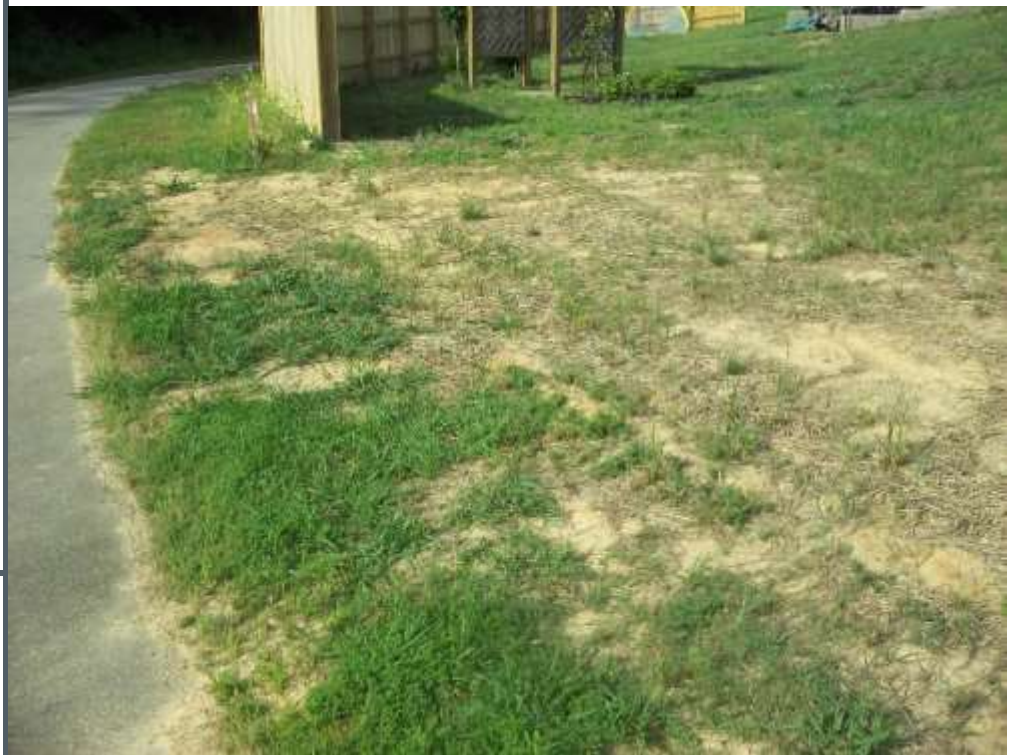
Photo No.

Bare soils uphill from greenway allow erosion, which leads to sedimentation

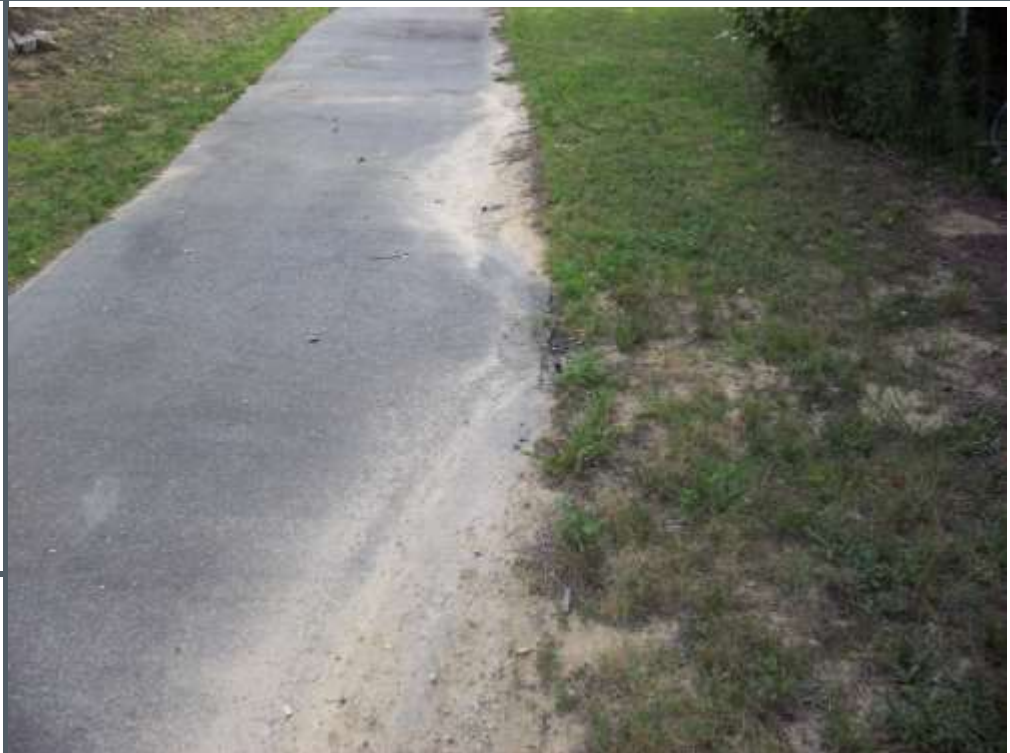
Photo No.

A high shoulder in this area forces runoff to concentrate at the localized low point in the greenway. This shallow concentrated flow is causing minor erosion on the shoulder, which will continue to worsen over time.

Area #2: high shoulder forces water to concentrate and runoff the greenway

We recommend the shoulder be fine graded to allow water to naturally sheet flow across the greenway, and ensure the asphalt is properly sloped in this direction. We recommend a 2% cross slope in all sections of the greenway (or as specified in the construction details). In addition, all bare soils should be properly vegetated.

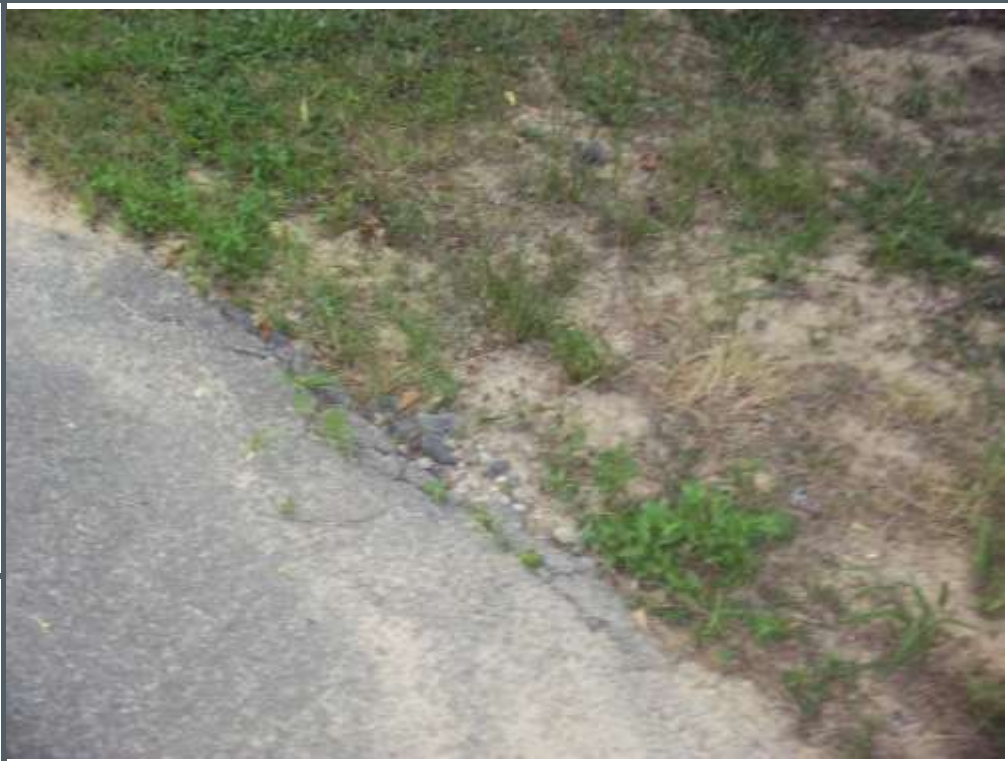
Photo No.
5

Description
Area #2: minor erosion
at shoulder

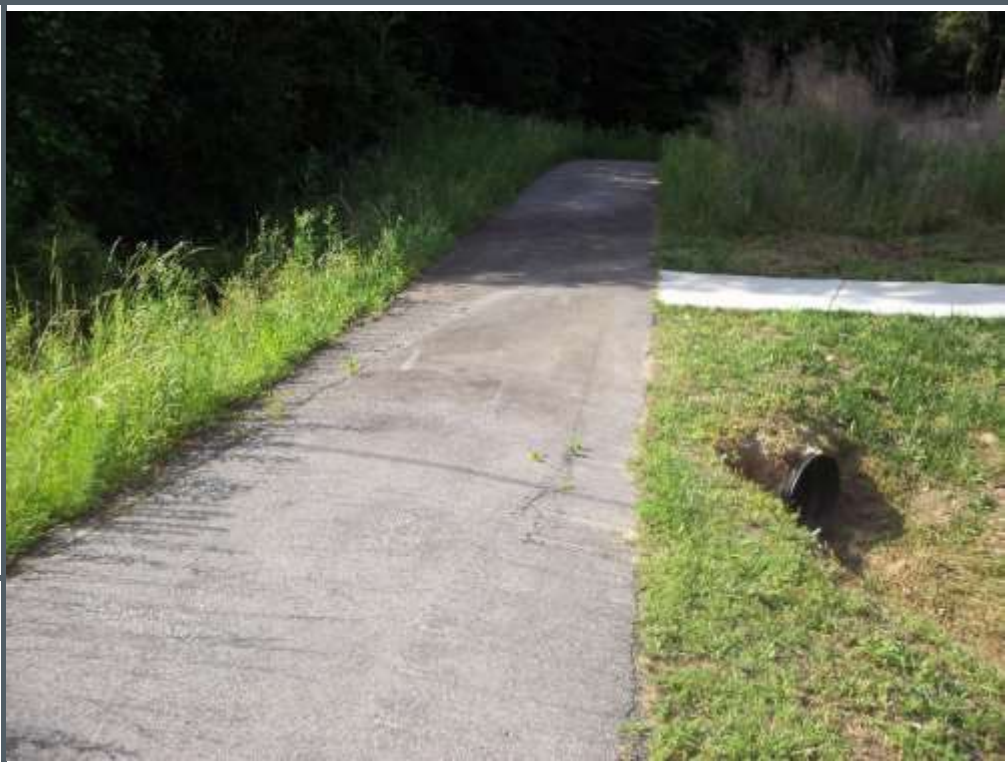
Photo No.
6

At this pipe crossing, we noted erosion at the upstream and downstream ends of the pipe. Typically, the slopes on the upstream side of open-ended culverts are protected with some type of armoring (a headwall, endwall, flared end section, or rip rap), and the outlet end of a pipe is protected with a rip rap dissipater pad due to the erosive flows. We recommend installing a flared end section on the upstream and downstream ends of the pipe and installing a rip rap dissipater at the downstream end of the pipe. Vegetation should be installed and maintained.

We also noted cracking and localized settlement of the asphalt, which is likely caused by either natural consolidation of the soil above the pipe due to poor initial compaction, or subsidence of the soil due to the erosion noted above. We recommend removal and replacement of this section of asphalt. The subgrade should be properly filled and carefully compacted.

Description
Area #3

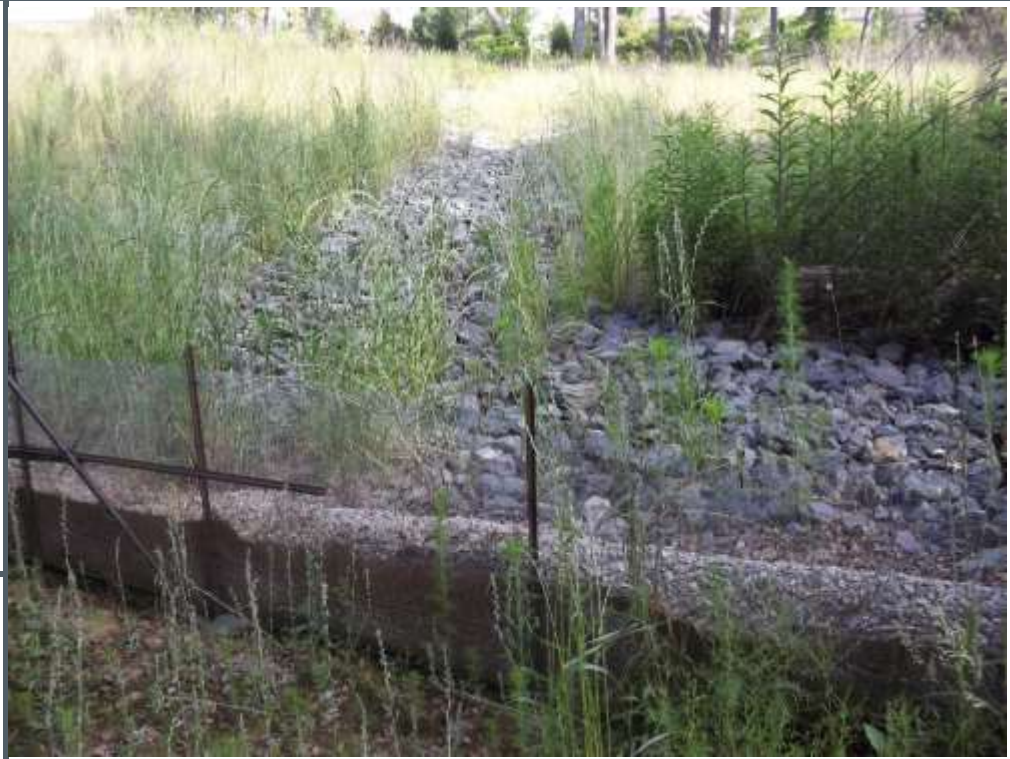
Photo No.
9

A rip rap swale carries flow toward and across the asphalt greenway in the natural area behind 114 Sugarbush Court. In our opinion, if a swale requires rip rap armoring due to excessive velocity or flowrates, it should pass through a pipe culvert below the greenway rather than flow across the top. We recommend installing a properly sized culvert below the greenway to carry the associated flows to the adjacent stream.

Area #4: rip rap swale
flowing through silt
fence outlet

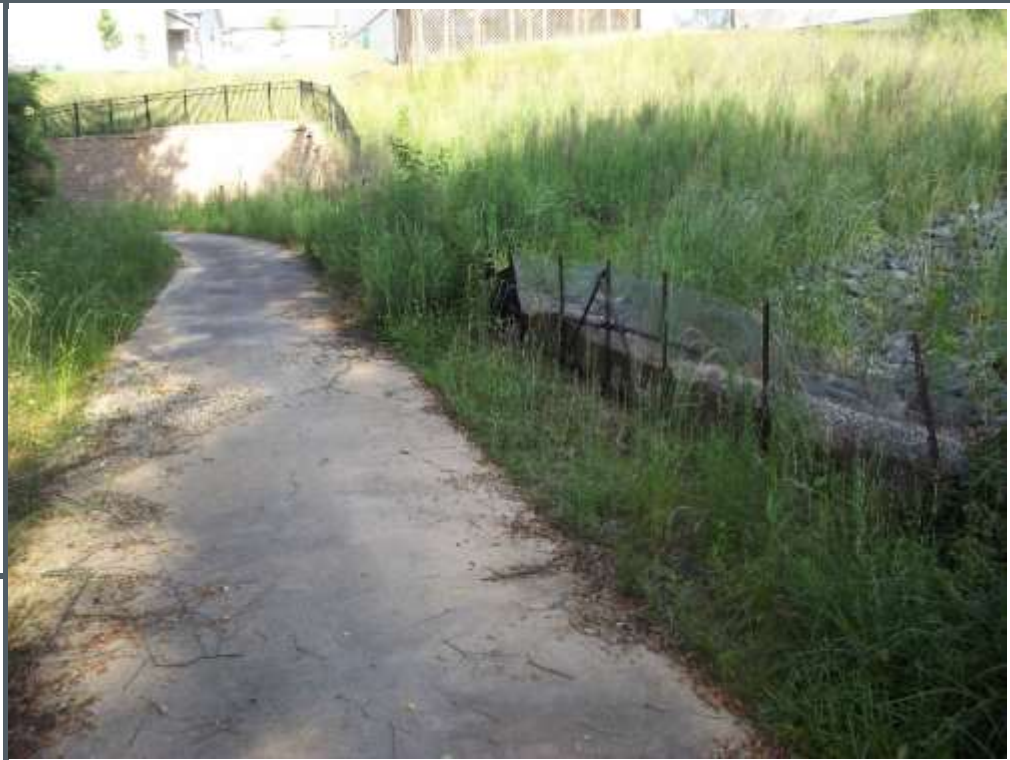
Photo No.
10

Area #4: flow from rip
rap swale discharges
across greenway

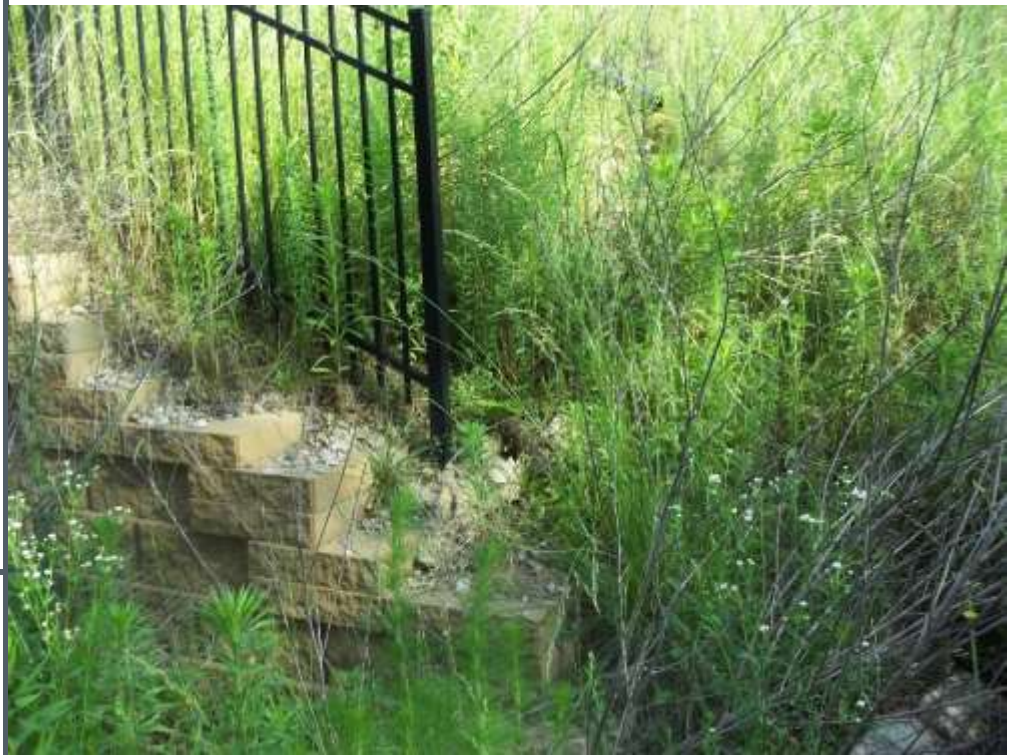
Photo No.
11

- The slope above the wall is poorly vegetated, with moderate erosion noted.
- Runoff appears to overtop the wall
- Moderate erosion was noted at both ends of the wall
- Bare soils and inadequate vegetation in all areas
- The greenway appears to be inadequately sloped toward the stream, with localized depressions noted
- A high shoulder was noted on the downstream side of the greenway

Area #5: erosion along retaining wall

We recommend the shoulders be fine graded to allow water to naturally sheet flow across the greenway, and ensure the asphalt is properly sloped in this direction. We recommend a 2% cross slope in all sections of the greenway (or as specified in the construction details). In addition, all bare soils should be properly vegetated. If fine grading alone cannot prevent ponding, a properly sized storm drainage system should be installed.

Most wall manufacturer's standard details include recommendations for a swale to be installed at the top of the wall to divert water toward the ends of the walls to prevent overtopping. We recommend consulting with the wall engineer to determine if this is acceptable. If not, the engineer should provide recommendations to re-direct flows away from the wall. At a minimum, the ends of the wall should be stabilized with an appropriately sized rip rap.

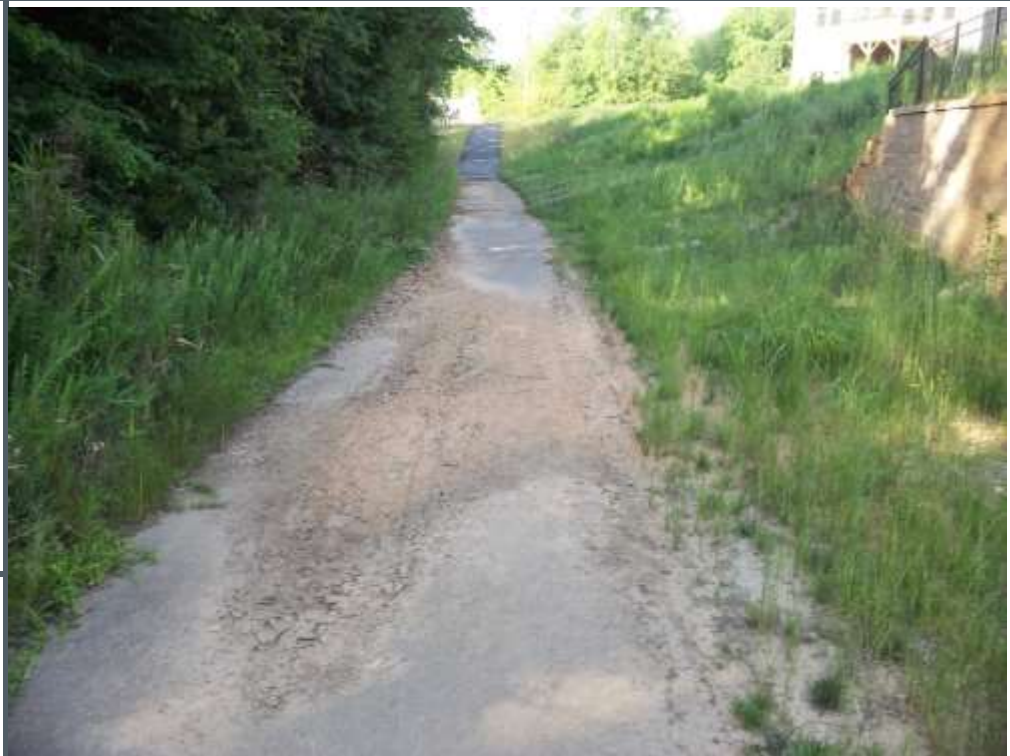
Photo No.
12

Area #5: sedimentation at base of wall

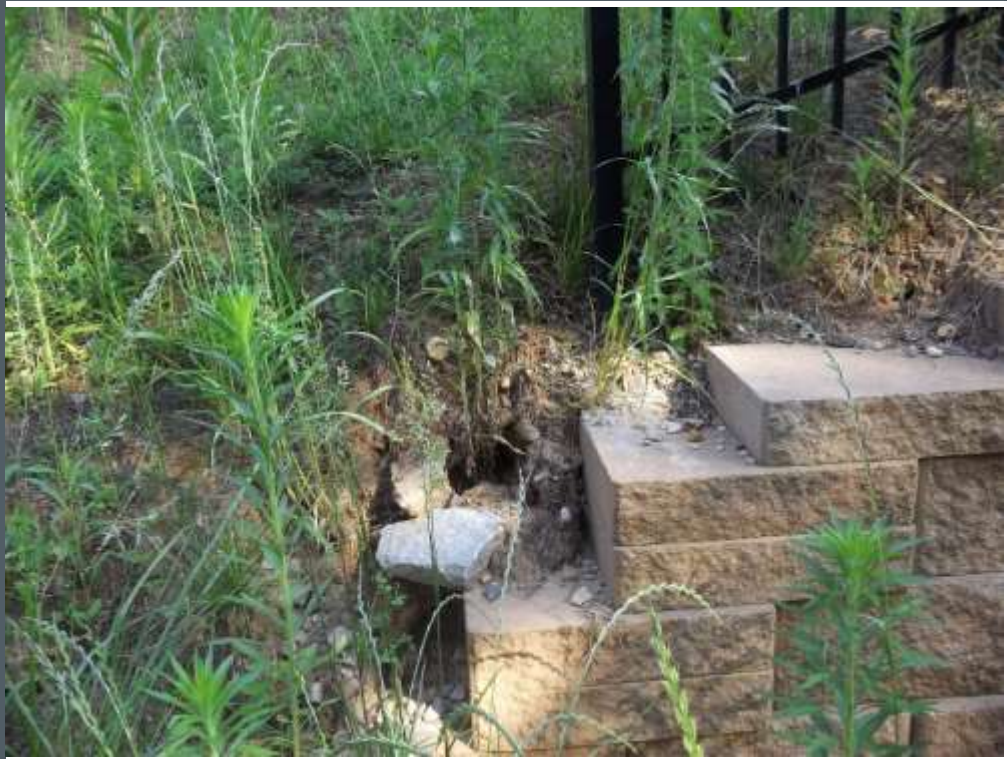
Photo No.
13

Description
Area #5: erosion at wall

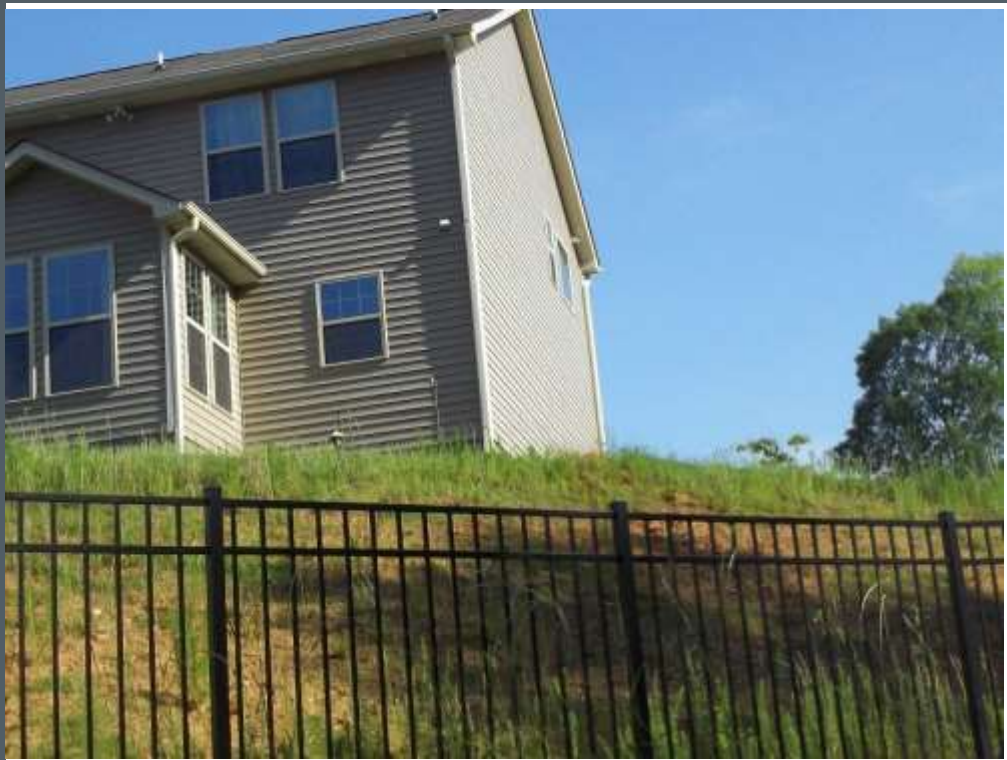
Photo No.
14

Description
Area #5: Erosion of poorly vegetated slope above wall

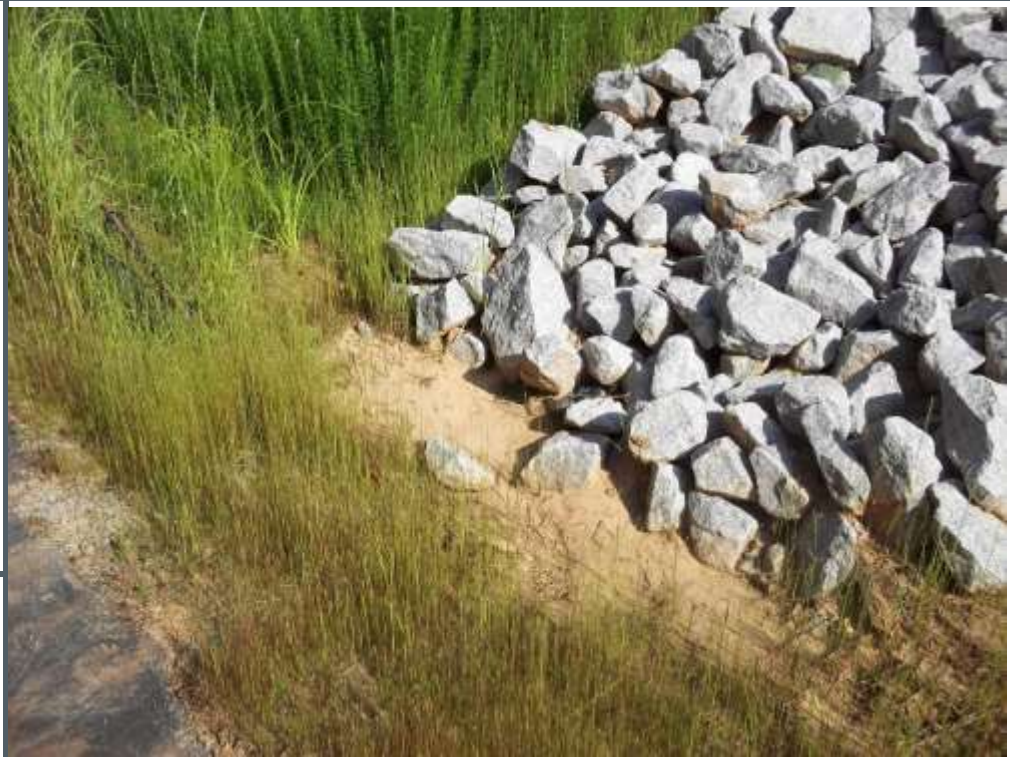
Photo No.
15

Two shallow grassed swales are located between the homes at 15-47 Sugarcane Drive, which flow into two rip rap swales along the steep portions of the slope at the rear of the properties. The swales discharge into a landscape swale/ditch, which is intended to flow along the side of the greenway. Though most of the area is overgrown with vegetation preventing adequate inspection, we did note sedimentation at the bottom of the rip rap which is creating a dam in the greenway swale. Evidence of water overtopping the greenway was noticed. We recommend the following improvements:

Area #6: rip rap swale transition to greenway swale; sedimentation in swale

- Mow the overgrown vegetation and install an appropriate groundcover (grass)
- Repair any erosion after mowing of vegetation
- Remove accumulated sediment
- Re-grade swale and rip rap transition to better allow flow in the greenway swale (currently, swale narrows at rip rap, which contributes to runoff overtopping the greenway)
- Stabilize all disturbed areas with rip rap/vegetation

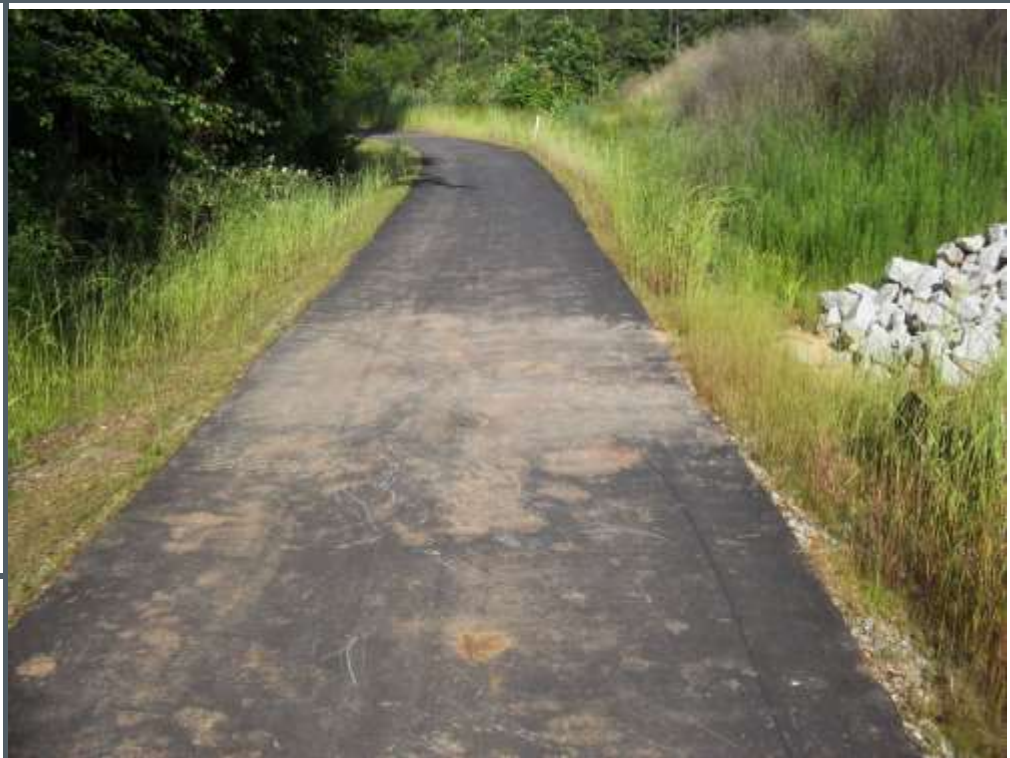
Photo No.
16

Area #6: evidence of overtopping of greenway

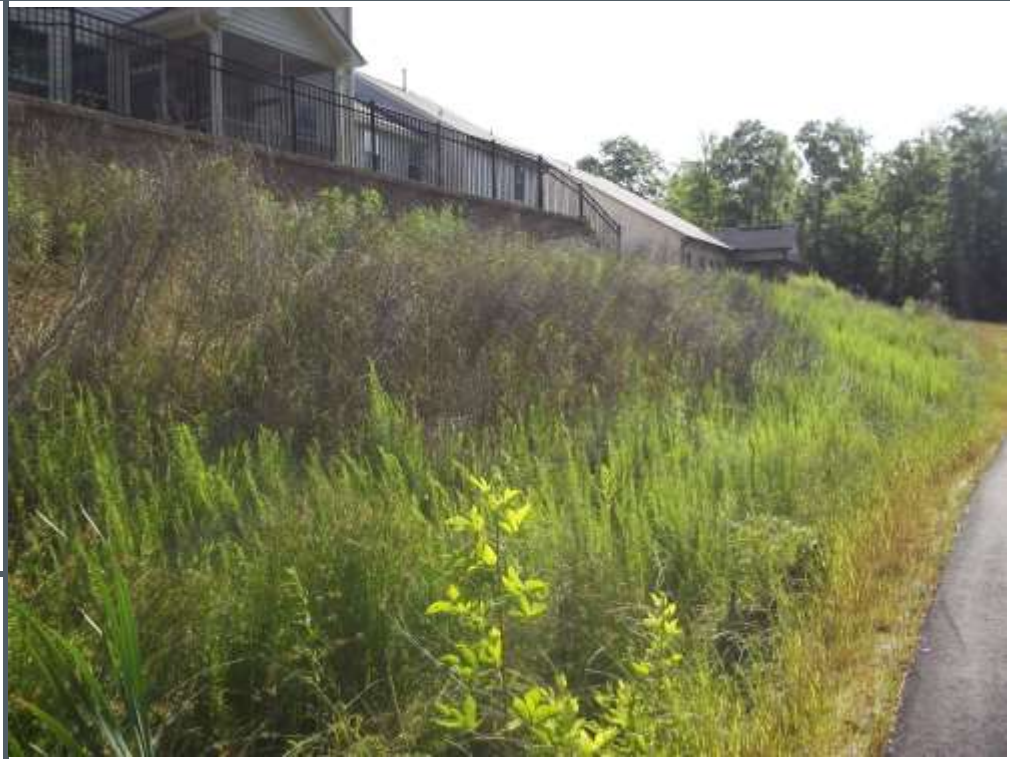
Photo No.
17

A high density polyethylene (HDPE) culvert flows below the greenway behind 63 Sugarcane Drive. The upstream side of the pipe is overgrown with vegetation, preventing adequate inspection. Inadequate protection at the downstream end of the pipe and erosion with a small sinkhole was noted at the downstream end of the pipe.

Area #7: overgrown
vegetation at upstream
side of culvert

We recommend removing the small washed stone at the downstream end of the pipe, carefully backfilling and compacting soil around the pipe outlet, and installing a rip rap dissipater pad. Additional repairs may be required based upon conditions visible after vegetation removal.

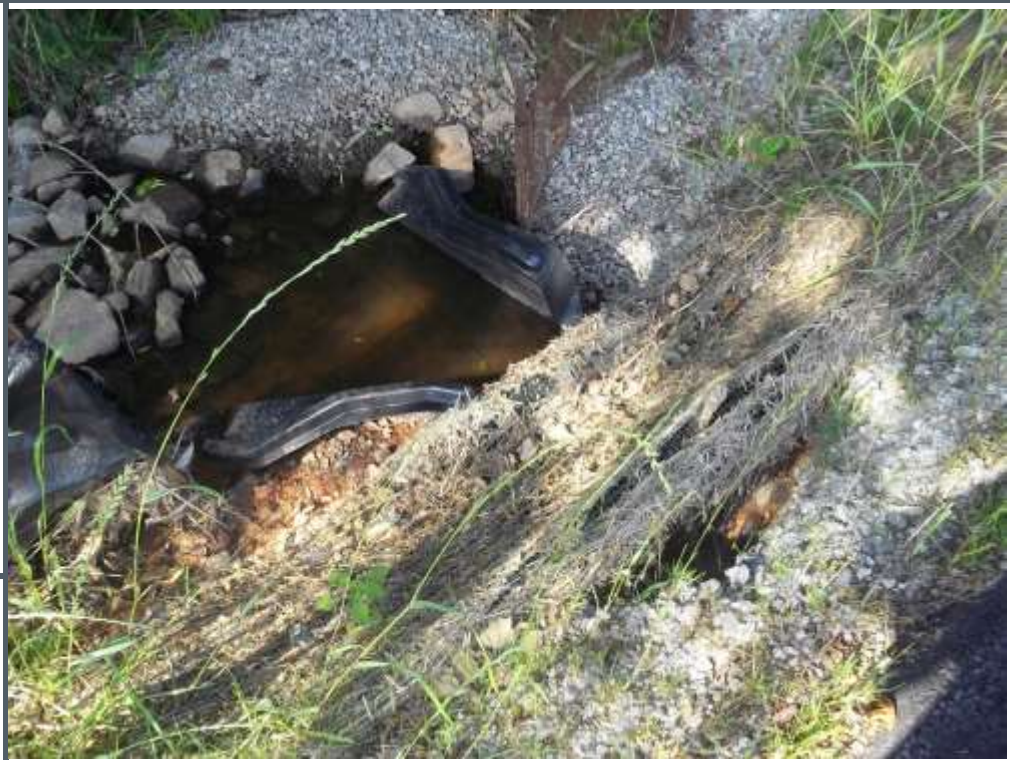
Photo No.
18

Area #7: erosion and
sinkhole at downstream
end of culvert

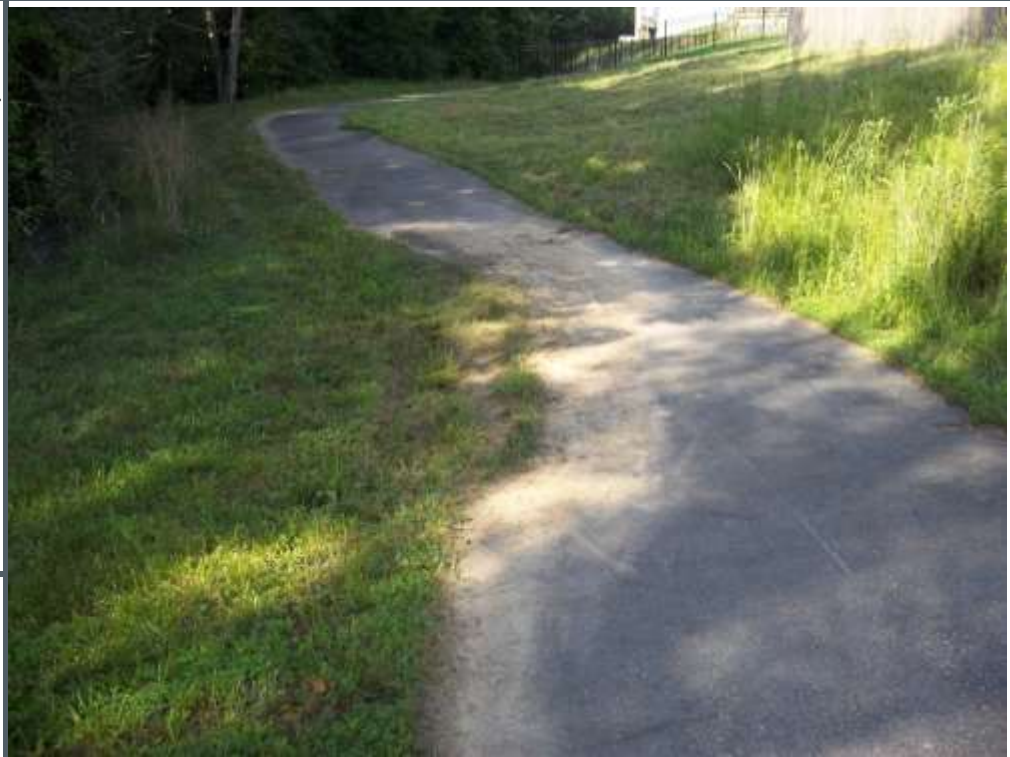
Photo No.
19

Near the rear of 73 Standing Oaks Lane, we noted a low/depressed area of pavement as well as a high shoulder which is causing sedimentation to occur on the greenway.

Area #8: Low/depressed area with a high shoulder on downstream side of greenway

We recommend the shoulder be fine graded to allow water to naturally sheet flow across the greenway, and ensure the asphalt is properly sloped in this direction. We recommend a 2% cross slope in all sections of the greenway (or as specified in the construction details). In addition, all bare soils should be properly vegetated.

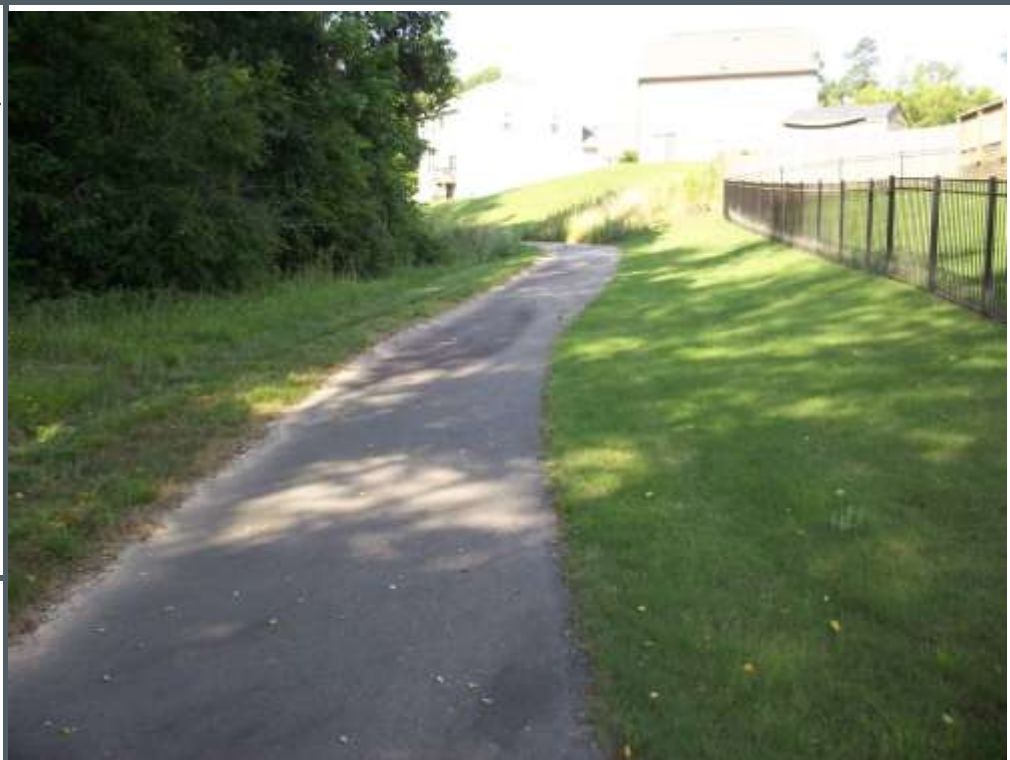
Photo No.
20

Area #8: Low/depressed area with a high shoulder on downstream side of greenway

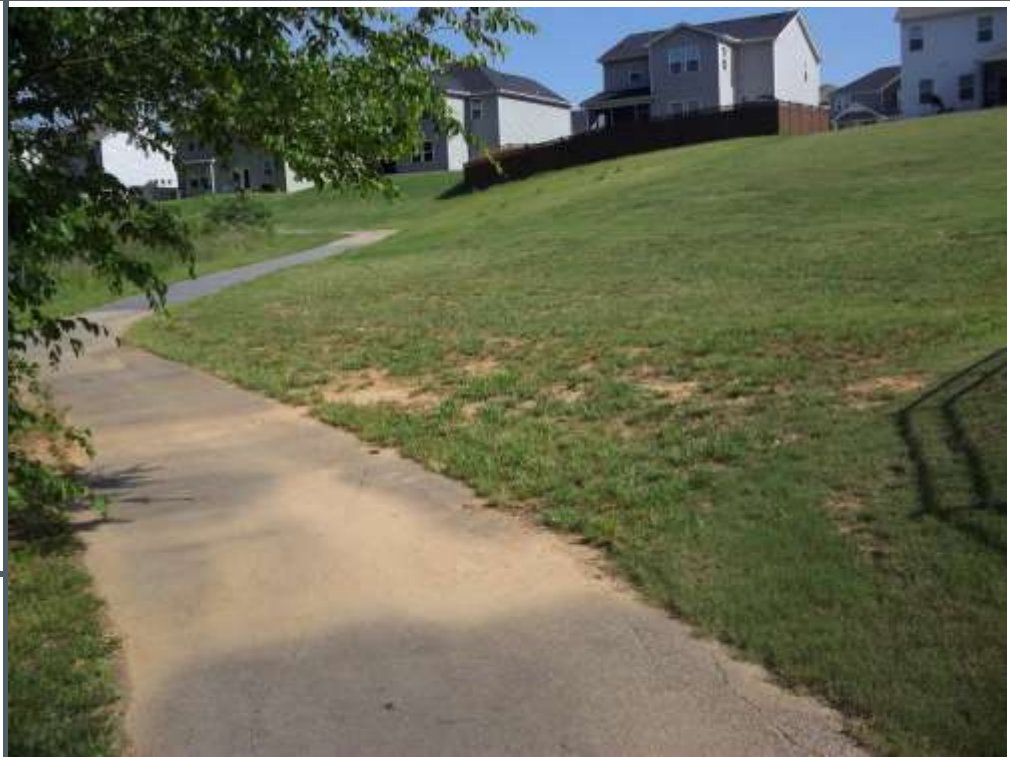
Photo No.
23

An area of open space creates a large amount of runoff that sheet flows across the greenway. The bare soils are beginning to erode, causing sedimentation at the high shoulder on the low side of the greenway.

Area #12: Large area of sheet flow crosses greenway, bare soils noted above with high shoulder on low side of greenway

Option #1: maintain adequate vegetation on grassed areas, and fine grade shoulder to allow positive flow across and away from greenway to prevent ponding.

Option #2: Install catch basin in open space area upstream of the greenway and direct runoff into the catch basin. The runoff can then be piped under the greenway in lieu of sheet flow across the greenway.

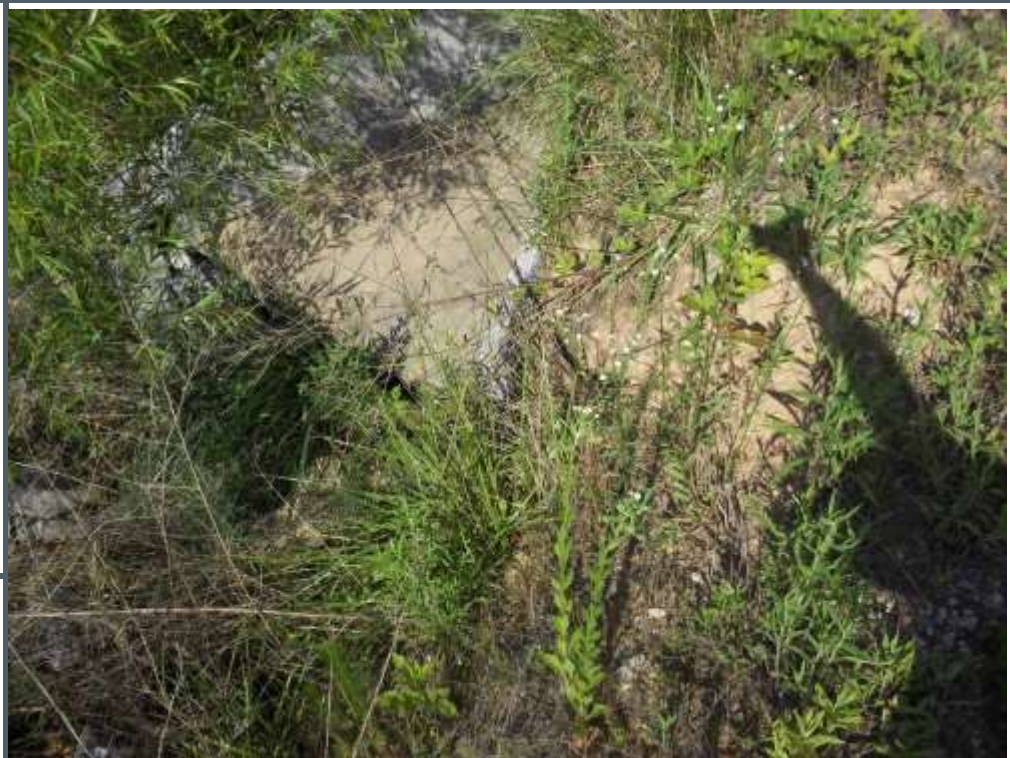
Photo No.
24

At the two pipe crossings, we noted erosion due to inadequate slope protection. On the downstream side of the pipe, the rip rap is inadequately sized for the flowrate and velocity as evidenced by the displacement of the rip rap and exposed geotextile fabric.

Area #13: erosion at downstream end of pipe

Ideally, the downstream end of the pipe would be extended to allow for a wider shoulder with a slope that is less steep. However, it is assumed the pipe ends due to the inability to extend into the stream buffer. Therefore, we recommend armoring the steep slope with additional, appropriately sized rip rap. We also recommend removal and replacement of the small rip rap with appropriately sized rip rap.

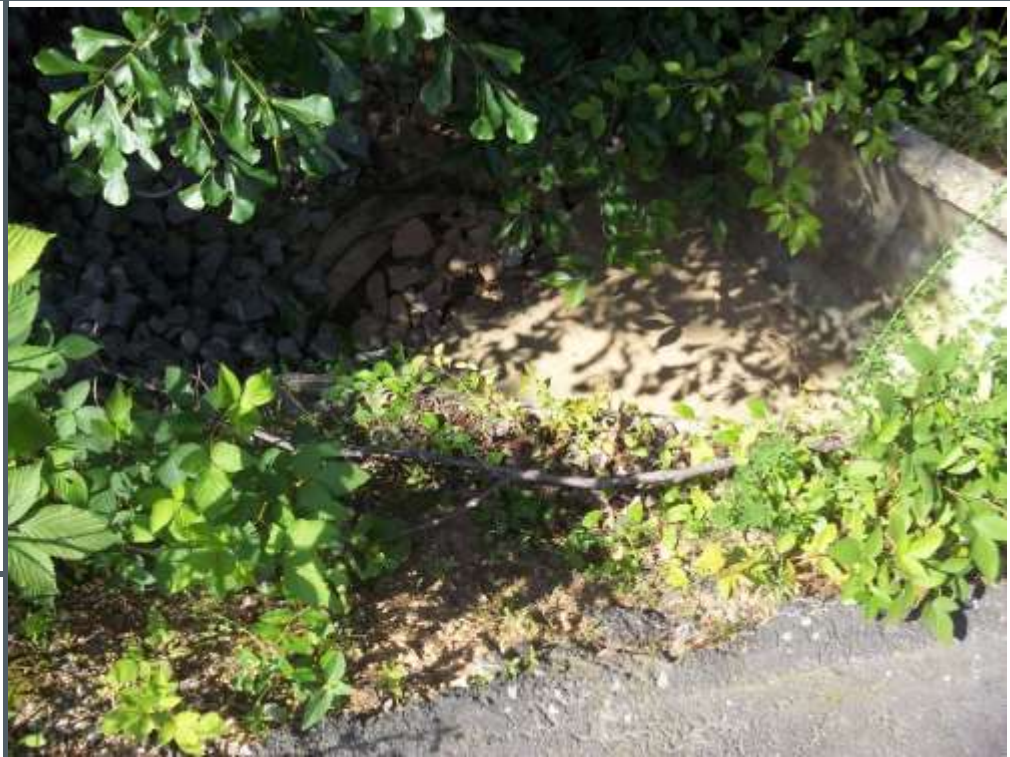
Photo No.
25

Area #14: Displacement of small rip rap at downstream end of pipe

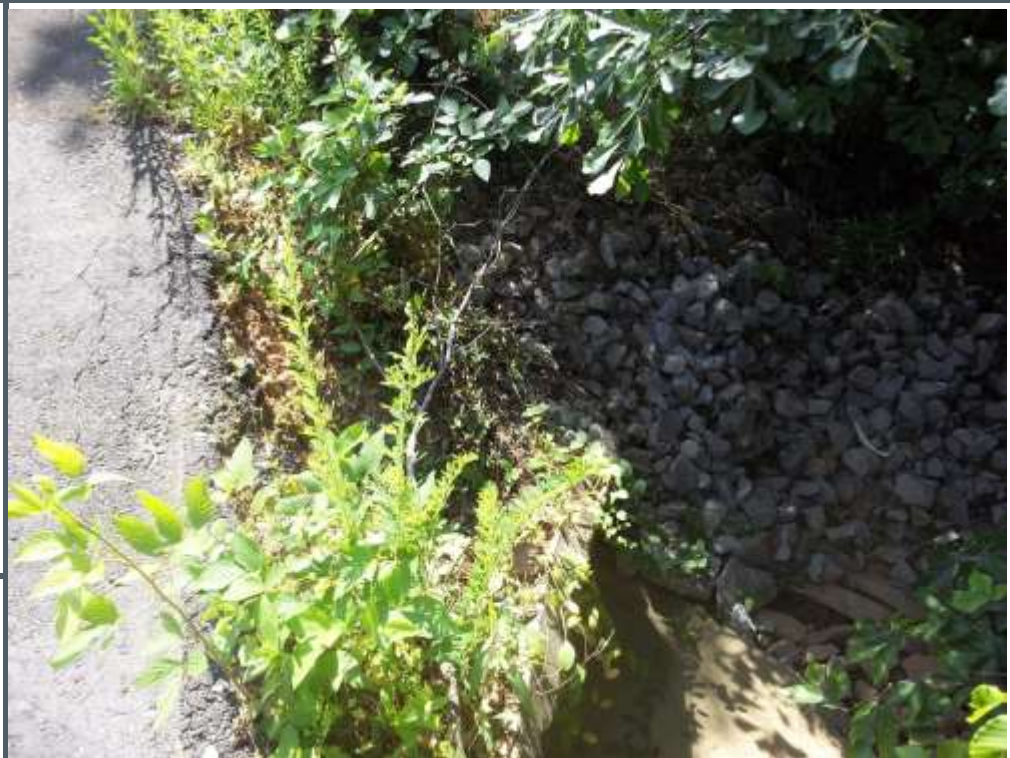
Photo No.
26

Area #14: erosion at slope of greenway

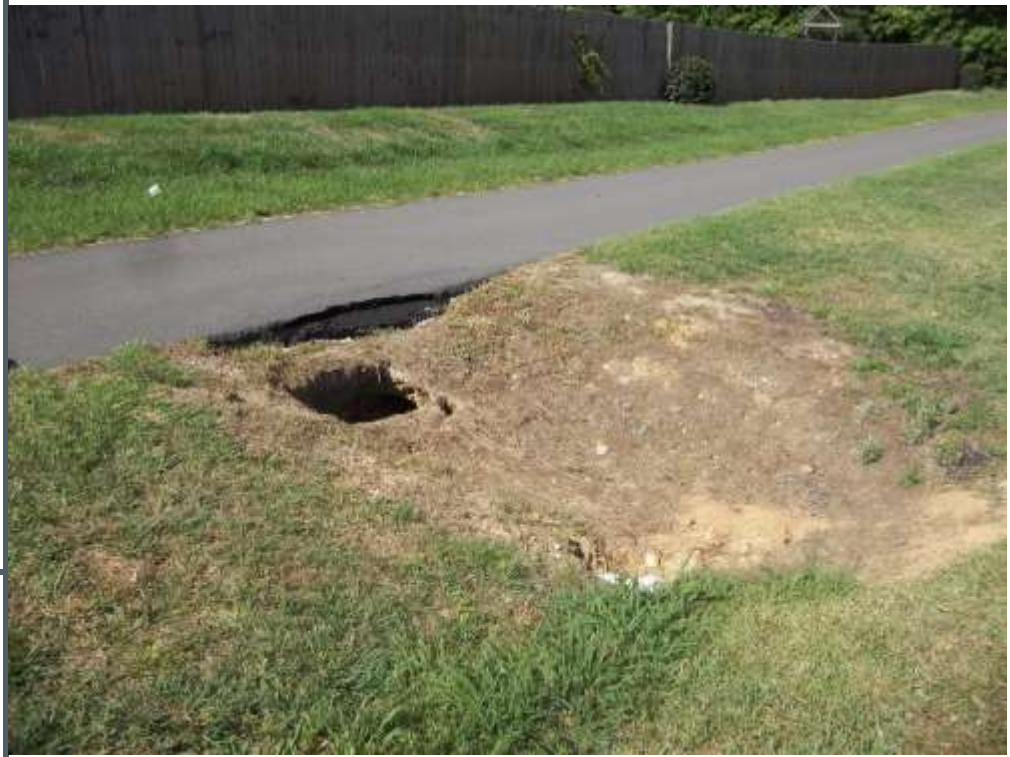
Photo No.
27

A landscape swale is located between the asphalt greenway and the gravel parking lot for the Town's dog park. A portion of the swale has eroded, with the erosion now extending to the greenway and is undermining the stone base.

Area #15: Area of erosion

We recommend filling the swale to a uniform contour. Typically, fill materials are easily erodible. Therefore, care should be taken to properly compact the backfill to approximately 85% standard proctor density. The area should then be sodded with a warm season grass to prevent erosion during any rain event. The sod may need to be stapled to prevent movement, and watered to ensure establishment.

If the sod does not become established, or erosion continues, the area will likely require armoring with rip rap over a non-woven filter fabric. The rip rap should extend to the edge of the asphalt greenway. The rip rap will need to be keyed into the existing grade, such that the top of the rip rap will be flush with the grass surface (not sit above the rip rap). While this will cause ponding of water in the rip rap, this is standard practice in order to mitigate erosion in the swale.

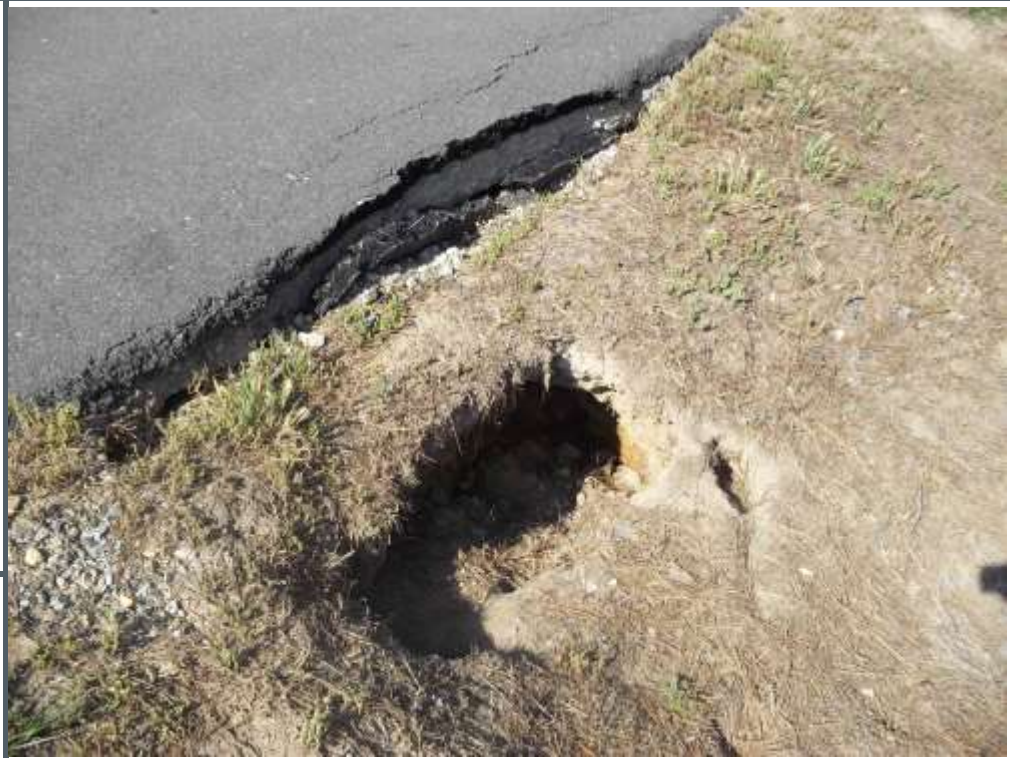
Photo No.
28

Area #15: erosion is beginning to undermine greenway
